Improving Water Quality in the Lick Creek Watershed by Improving the Performance of Septic Systems

Charles Humphrey Jr., Guy Iverson, Christa Sanderford

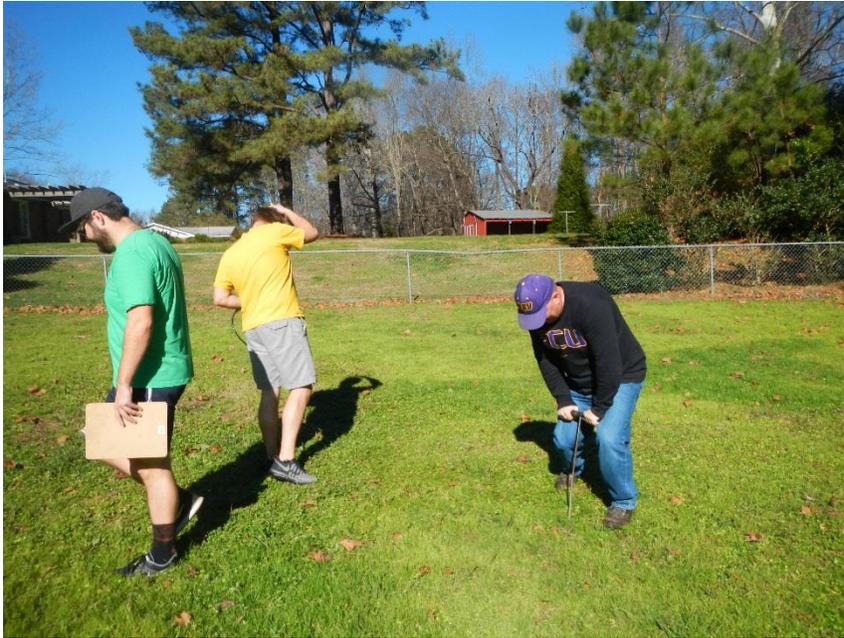
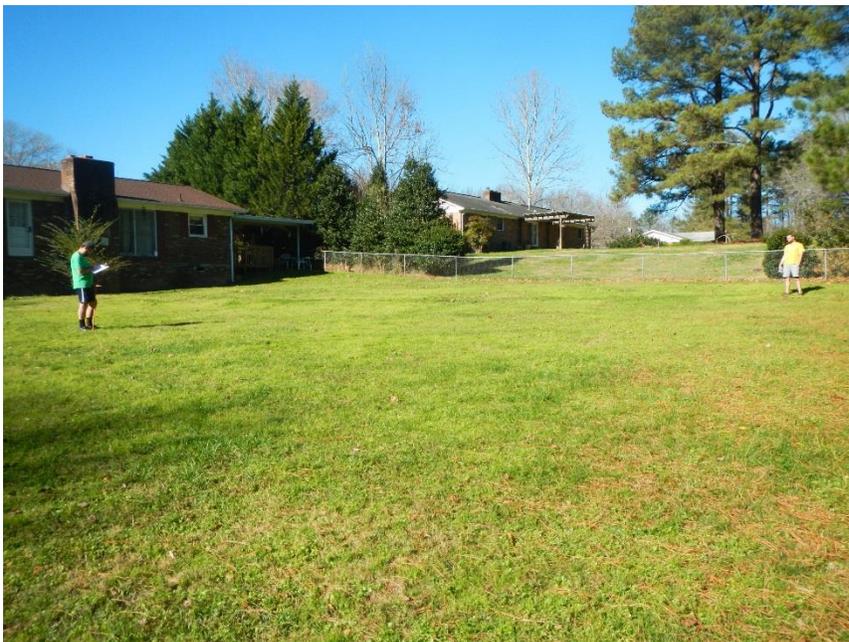
Walking surveys were conducted in the watersheds with relatively poor water quality and a high density of septic systems. Information from the septic system permits was used to help locate system components. Soil and site conditions were evaluated to assess potential options for septic system repairs.

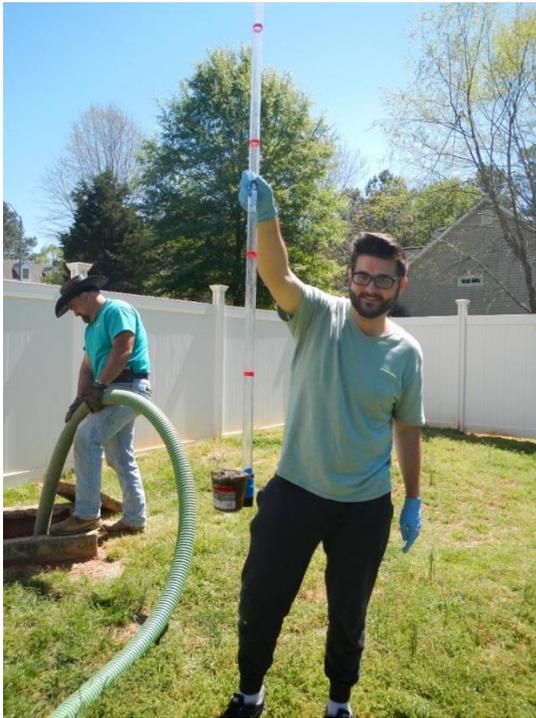
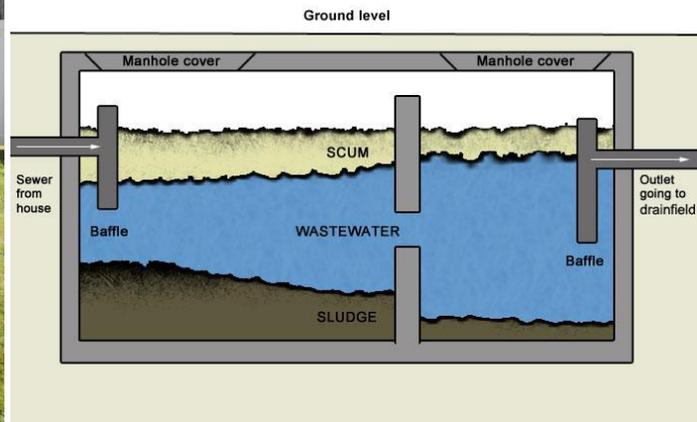
Septic contractors were met at properties where the septic tanks needed pumping. The layer (scum, liquid, sludge) thickness was measured for each tank and samples of the layers were collected for nutrient analyses. The volume and concentrations were used to determine masses of nutrients pumped from the tanks.

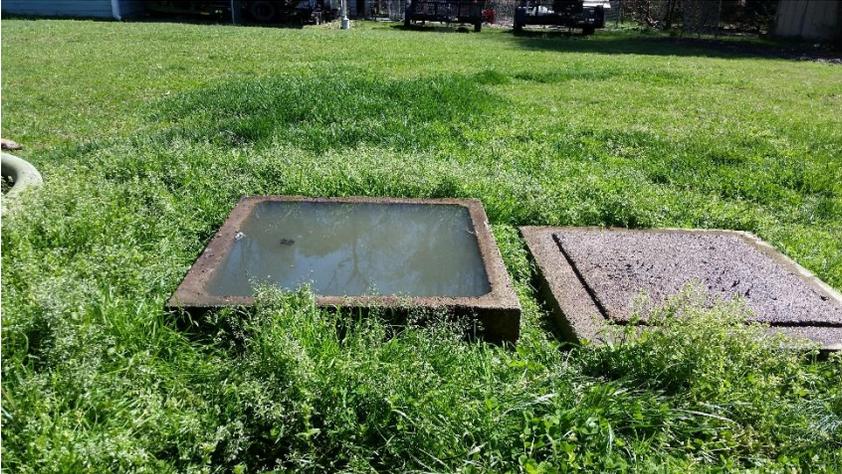
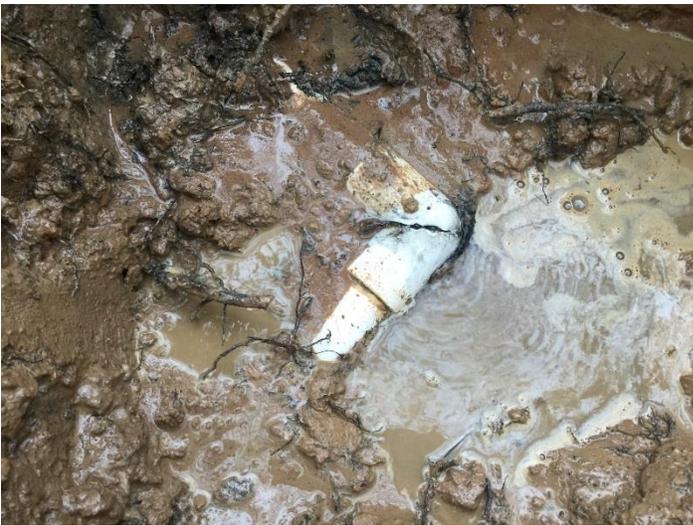
Malfunctioning septic systems were located and repair options considered. One property with a pump system, had a cracked supply line that was discharging effluent to the surface, and the runoff was reaching a nearby creek. The supply line was repaired.

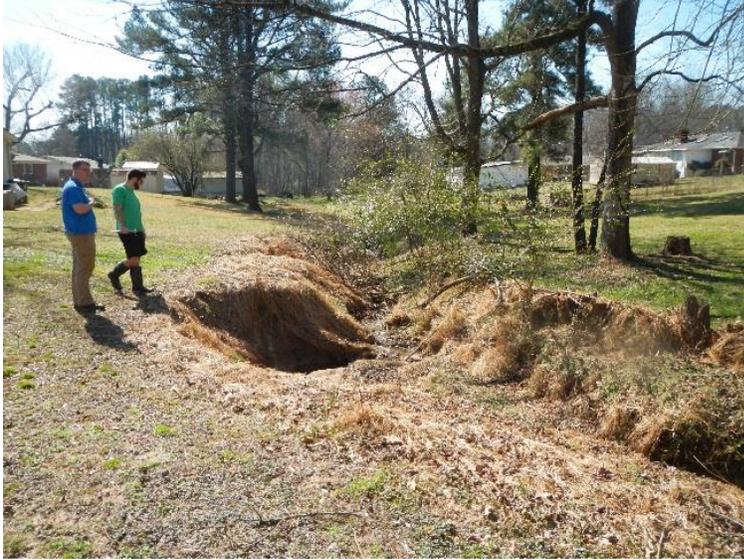
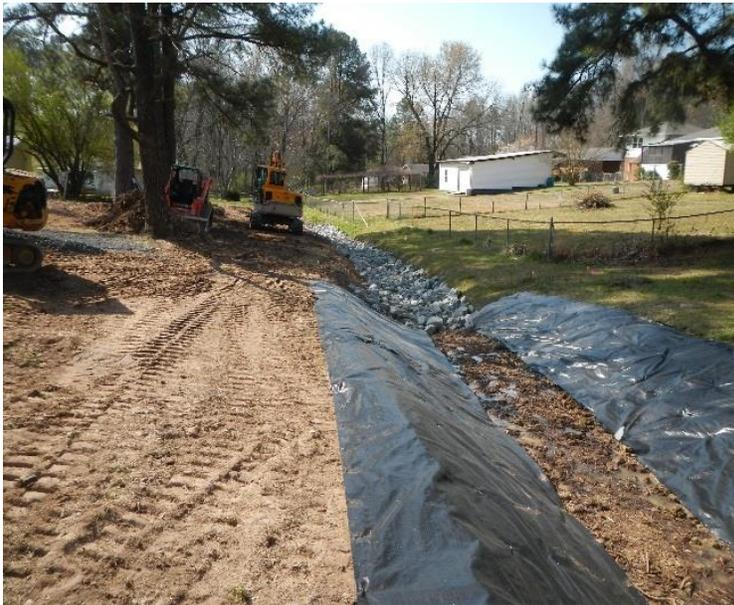
Severely eroded sections of a drainageway (left side images) were stabilized by widening and reshaping the banks. Woodchips and expanded media were placed in the bed of the drainageway, and covered with stone. These modifications have reduced pollutant transport by more than 30%.
