Middle Fork New River Restoration

Section 1B

Restoration Project Description

Middle Fork New River Section 1B - Photosheet

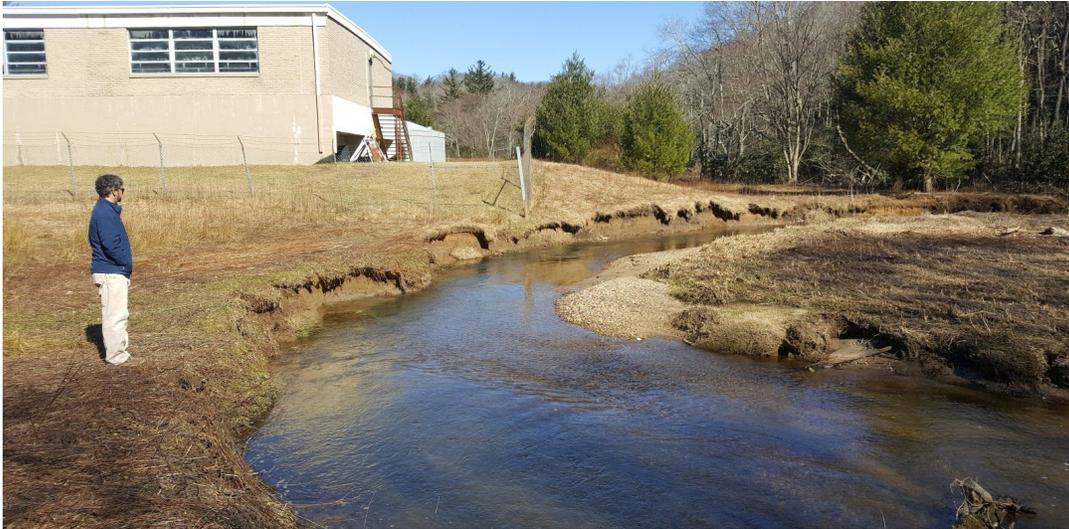
NRC President, George Santucci, on river left observing the severe erosion along the property boundary of the Blowing Rock Water Plant.

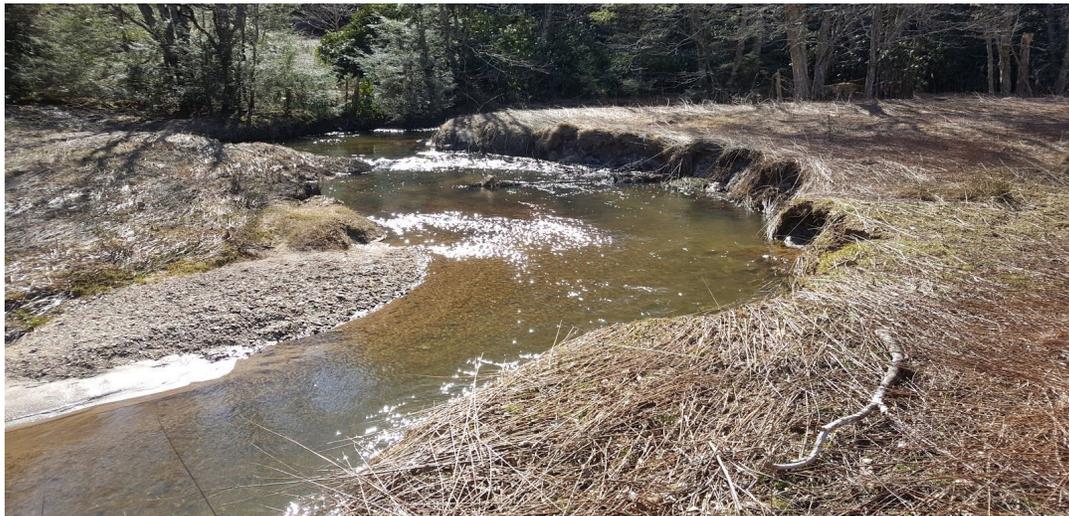
Tortuous sinuosity and sedimentation observed looking upstream on Blue Ridge Parkway property.

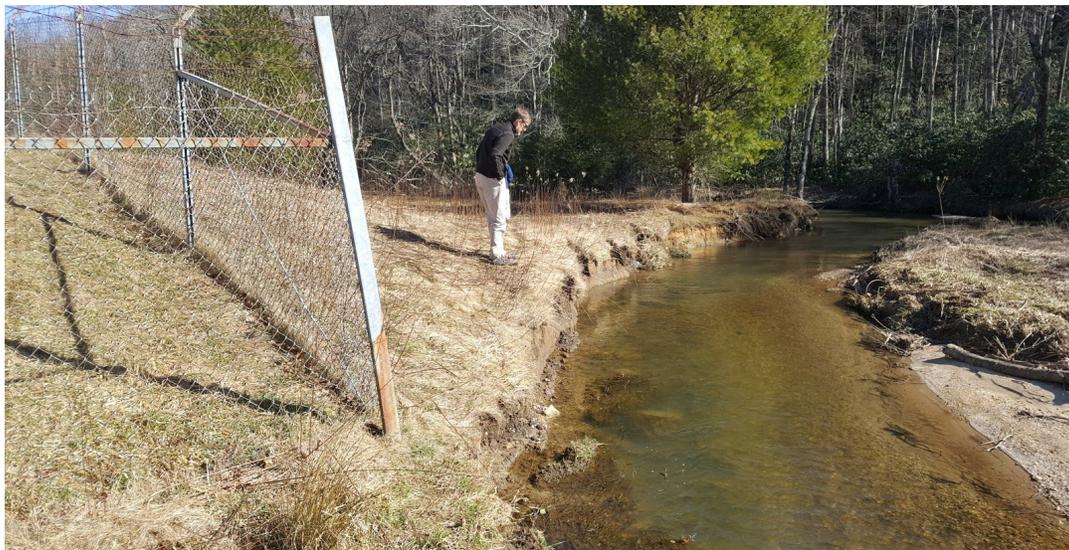
NRC board member, Mike O'Connor, standing river left of an eroding stream bank on Blowing Rock property.

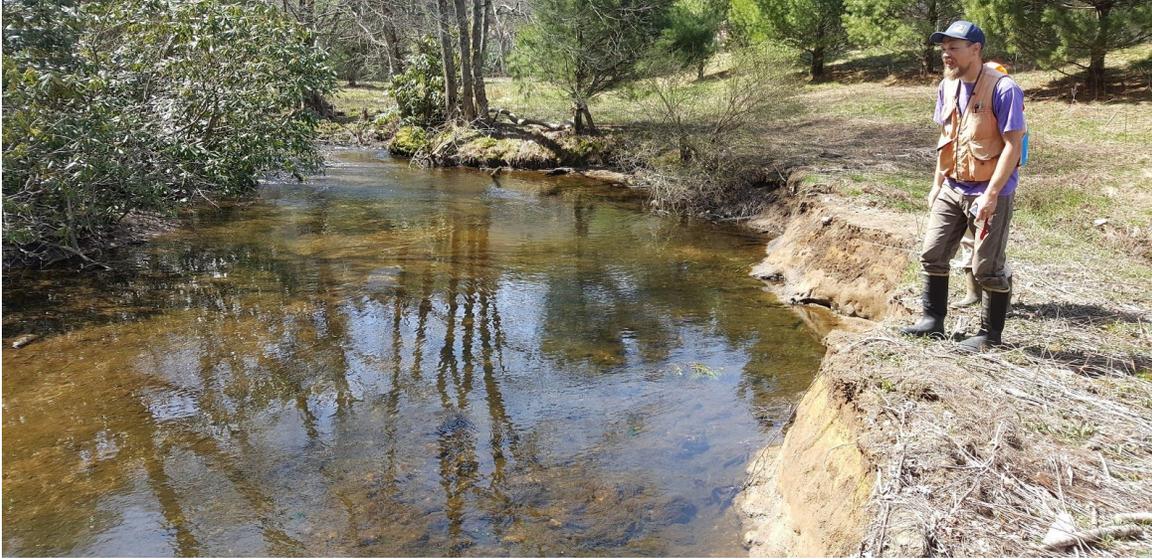
Jonathan Hartsell of Blue Ridge RC&D standing river left of a severely eroding stream bank on Blue Ridge Parkway property.

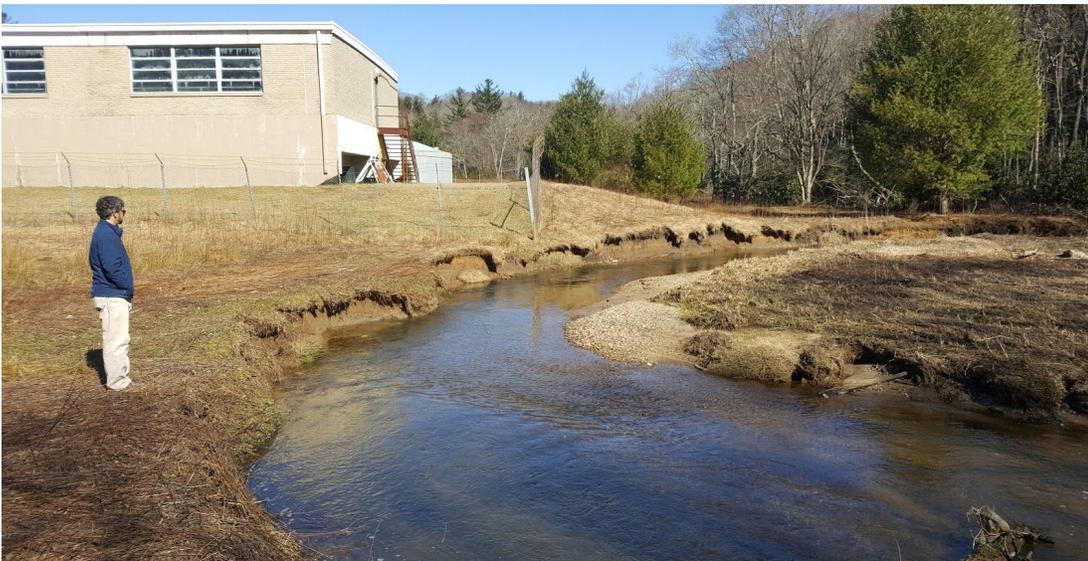
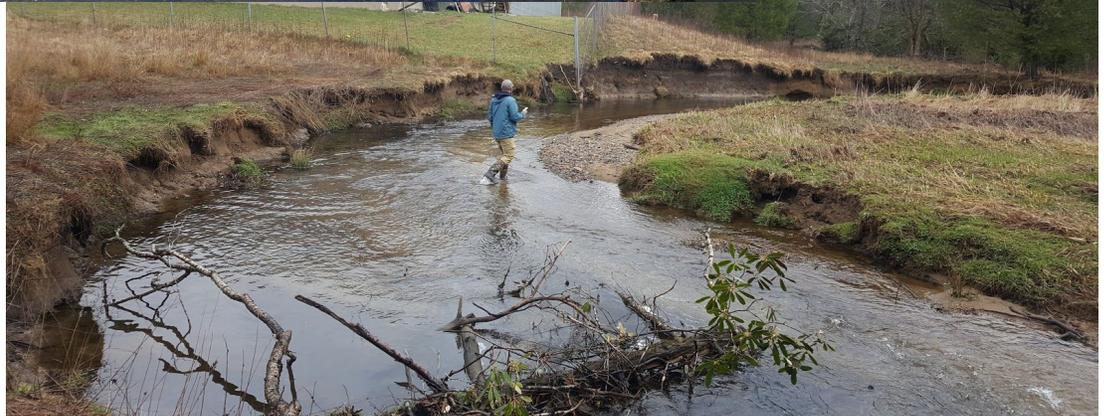
Riverbanks are actively eroding and have changed drastically over the last year further emphasizing the importance of this restoration project. Below are photos of the same location taken one year apart. The building visible in the photo is the Blowing Rock Water Treatment Plant - currently threatened by the erosion.
