The University of North Carolina at Chapel Hill's

Battle Grove Regenerative Stormwater Conveyance

The University of North Carolina at Chapel Hill's Battle Grove Regenerative Stormwater Conveyance Supporting Information

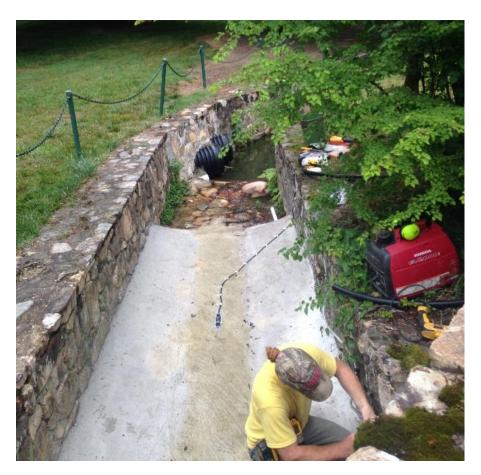
Figure 5. NCSU staff installing monitoring equipment at the site.

A secondary objective of the project was to provide data to support the use of Regenerative Stormwater Conveyances in North Carolina and quantify pollutant removal provided by the practice. UNC-CH partnered with North Carolina State University (NCSU) to implement a paired watershed monitoring study that compares the 20-acre watershed treated by the RSC to the adjacent 19-acre watershed. Pre-project monitoring was completed in 2015, with post-project monitoring starting the fall of 2017 and continuing through mid-2018. Due to dry conditions, no post-project monitoring data are available at this time. UNC-CH has also established a long-term macroinvertebrate monitoring station downstream from the site.
